Slope Failure studies through Kinematic analysis using Markland's test from Rali-Kashpo village, Himachal Pradesh, India

Satish Kumar^{1*}, Sushil Kumar², Yashpaul¹

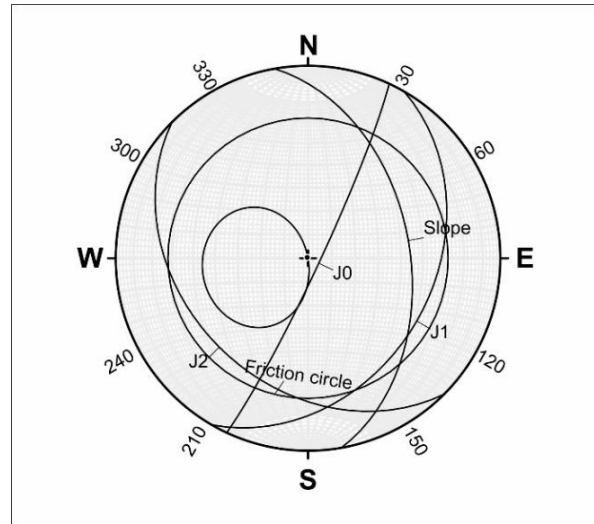
Fig. 3: The stereographic projections of discontinuities and slope data for site RK01.

The structural data of the slope and discontinuities for RK01 are represented in Fig. 3. In this projection wedge formed by the intersection of J1 (second joint set) and J2 (third joint set) does not qualify for any of the conditions. Thus, the slope can be defined as safe as per the method used in the current study. However, J2 can be a problematic discontinuity.

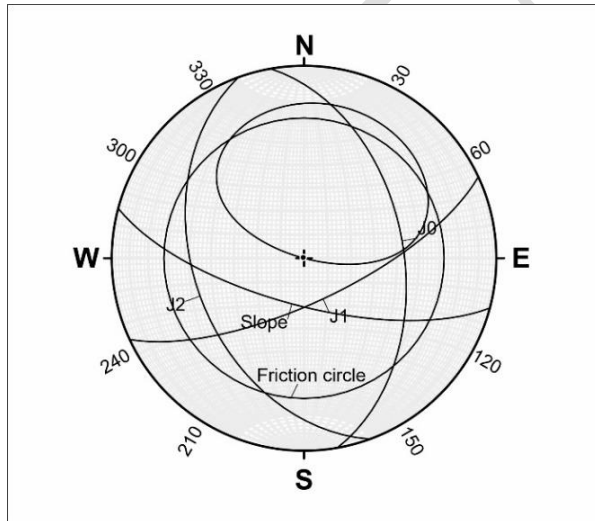
Fig. 4: The stereographic projections of discontinuities and slope data for site RK02.

The structural data of the slope and discontinuities for RK02 is represented in Fig. 4. In this projection only J1 qualifies the first condition of Markland’s test where J1 is gentle than slope inclination and steeper than the angle of internal friction, but does not qualify for second condition of Markland’s test due to its orientation. Thus it can be said that the slope is critical but did not show any mode of failure. If, in any case, slope daylight under the influence of any other cause, the chance to fail along J1 (planar slide) will be high.

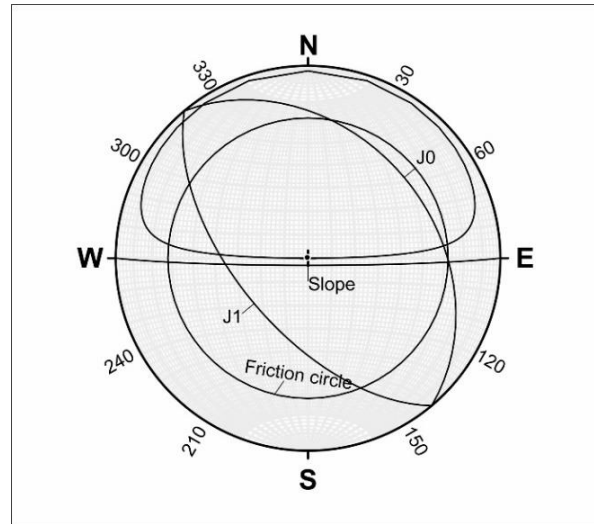
Fig. 5: The stereographic projections of discontinuities and slope data for site RK03.

The structural data of the slope and discontinuities for RK03 is represented in Fig. 5. Three wedges between J0-J1, J0-J2, and J1-J2 were observed after the analysis of field data. In this projection, J2 qualifies for the first condition of Markland's test where the slope is steeper than J2 while the angle of internal friction is gentle as compared to J2, but does not qualify the second condition of Markland's test. In the same way, the wedge formed by the intersection of J1 (first joint set) and J2 (second joint set) but did not satisfy any condition because the plunge of the intersection is more gentle than the angle of internal friction. In the above two cases wedge failure is more prominent as compared to planar failure. Hence, the slope can be defined as critical.

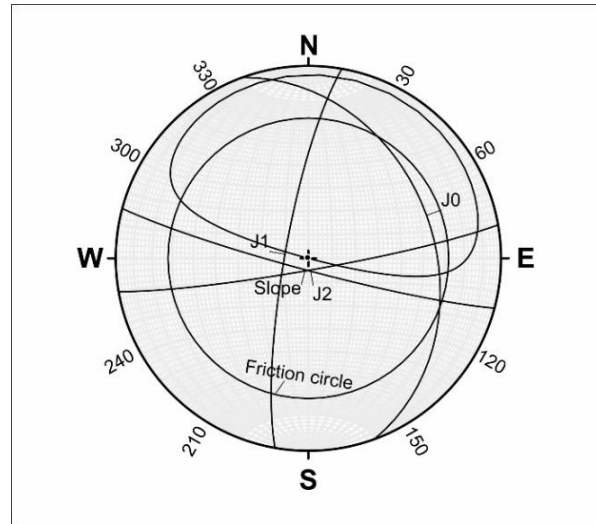
Fig. 6: The stereographic projections of discontinuities and slope data for site RK04.

The structural data of the slope and discontinuities for RK04 is represented in Fig. 6. In this projection J1 qualifies the first condition of Markland's test where J1 is gentle than slope inclination and steeper than the angle of internal friction but does not qualify the second condition of Markland's test. Thus it can be defined that slope is critical only. If the slope fails by any other factor (not discussed here) the possibility of failure along J1 (planar failure) will be high.

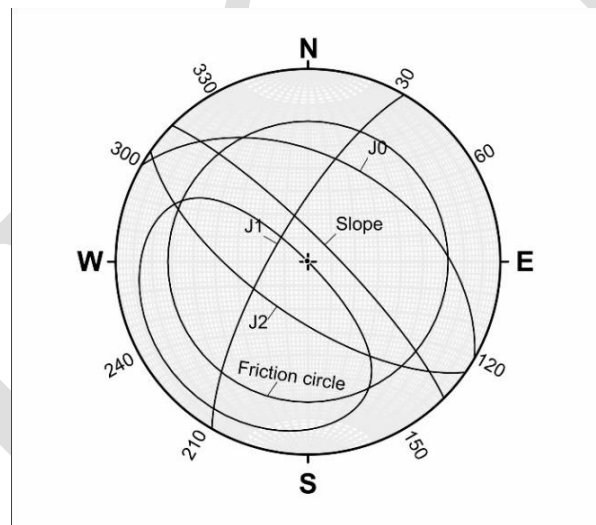
Fig. 7: The stereographic projections of discontinuities and slope data for site RK05.

The structural data of the slope and discontinuities for RK05 is represented in Fig. 7. In the above stereonet there are two cases (1) Wedge formed by J0 and J1, and (2) Planar along J0. Both cases qualify for the first condition of Markland’s test, while the first case is disqualified in the second condition. In the second case, the foliation plane dips in a nearly parallel direction to the direction of inclination of slopes. Hence, with this study, the mode of failure is observed as planar failure along J0.
